HOLY TRINITY CHURCH, GUILDFORD
REMEDIAL CONSERVATION TREATMENT OF THE APSE DOME PAINTINGS
MAY 2016

Report No: GDHT01.2 **Date:** 13th May 2016

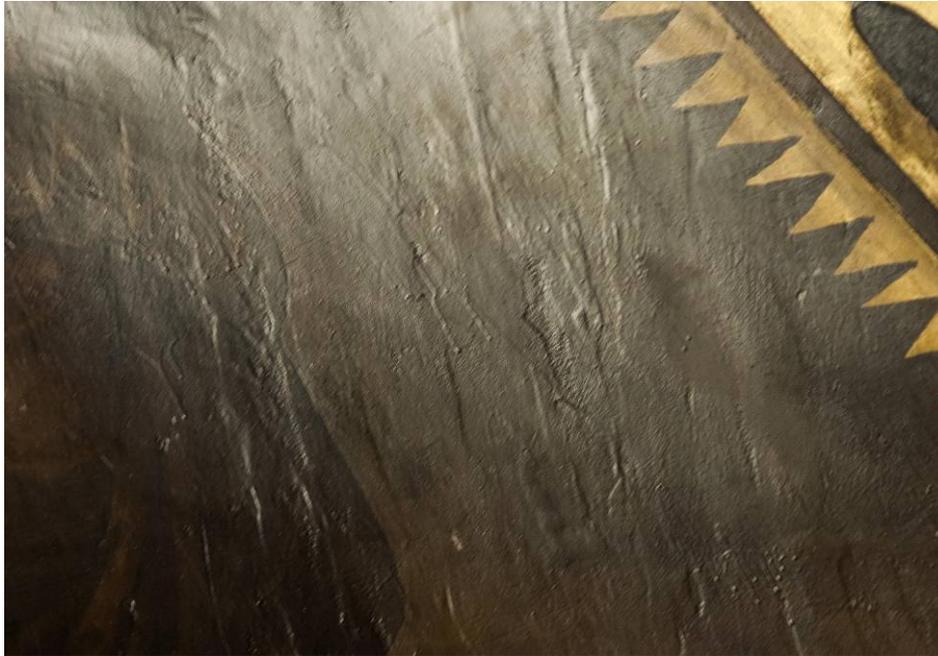
The vault appears to be of brick construction and is rendered with a hard plaster, presumably lime based. This is coarsely applied and in raking light the tool marks are clearly visible.

Figure 5. Coarsely applied plaster on the vault.

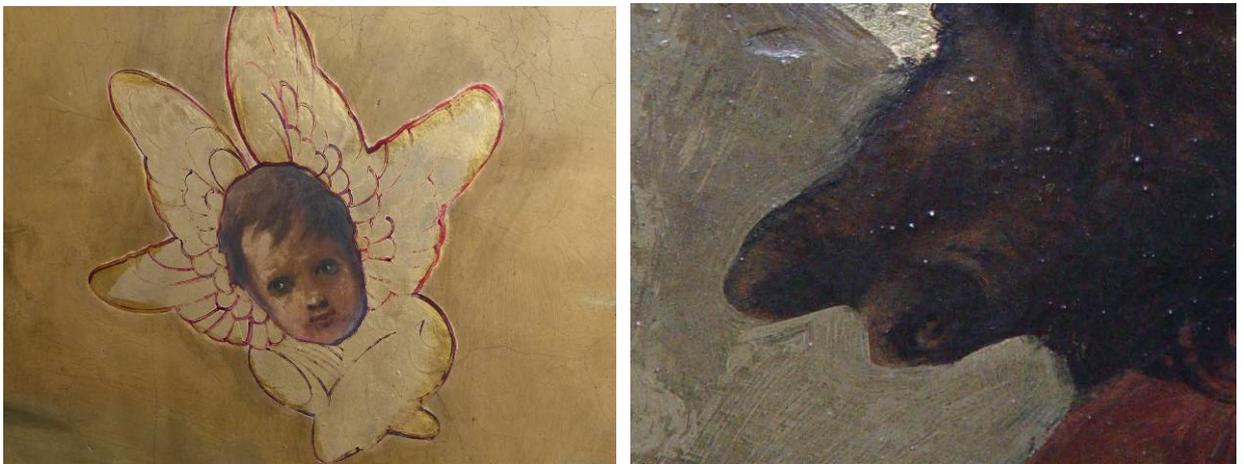
No documentary record of previous interventions is known. However, it can be seen that the entire painting has been coarsely cleaned removing some of the painting, including details of the putti's wings. The background was originally painted (or repainted) in large areas and the whole area was heavily varnished (with numerous drip marks), which has since discoloured. This may have occurred on more than one occasion.

Figures 9 & 10. Paint loss due to aggressive cleaning and repainting of the background. (Images: Claudia Fiochetti)

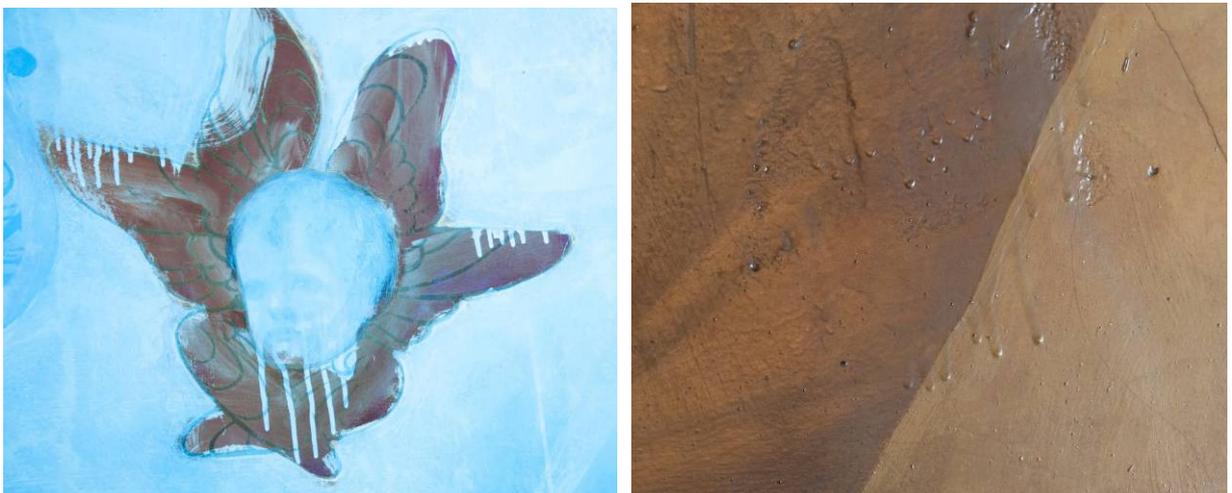
Figures 11 & 12. Areas of varnish runs in UV and visible light. (Images: TCA and Claudia Fiochetti)

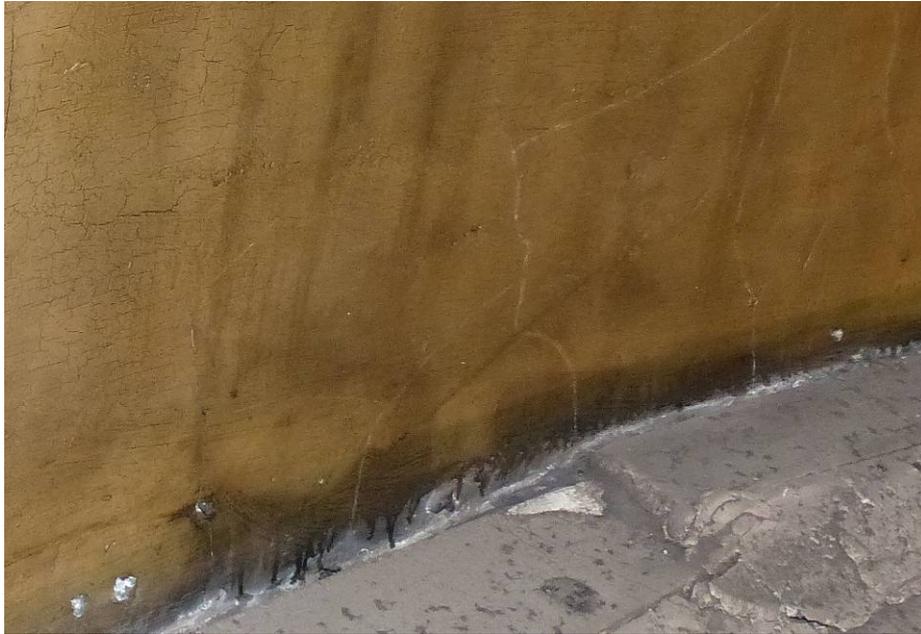
It was noticeable that, in many areas, the new varnish had become mixed with dirt which had been smeared onto the surface of the painting. It was clear therefore that the paintings were relatively dirty and for this reason it seems likely that a cleaning exercise would have taken place first, although this may suggest that this was not carried out with particular care.

Figure 13. The dirt layer has been mixed with the varnish and smeared over the background of the painting.

- *Cleaning:* The aim of the cleaning was to remove the superficial dirt layers but not the discoloured varnish. The loose surface dirt was carried out using soft brushes and Akapad sponges. The fine adhered dirt layer was reduced using a 2.5% solution of tri-ammonium citrate in deionised water, applied on cotton wool swabs. Clearance was with deionised water.

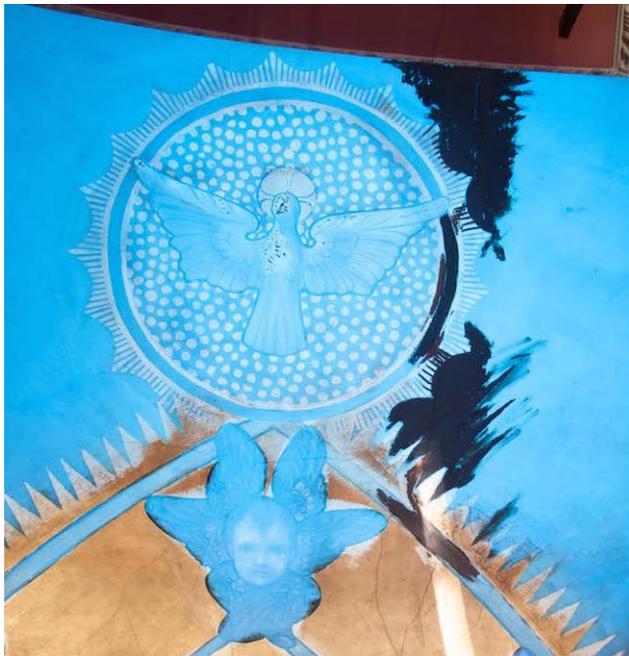
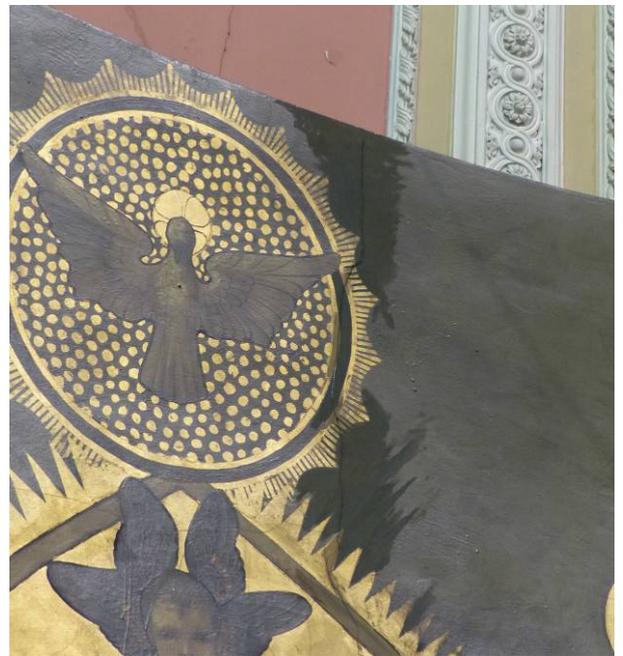
Later rough retouching was observed in a number of areas of the background, sometimes on sections of plaster around cracks, but also on areas of mechanical damage.

Figures 14 & 15. Areas of retouching on the Holy Spirit in UV and visible light. (Images: TCA and Claudia Fiocchi)

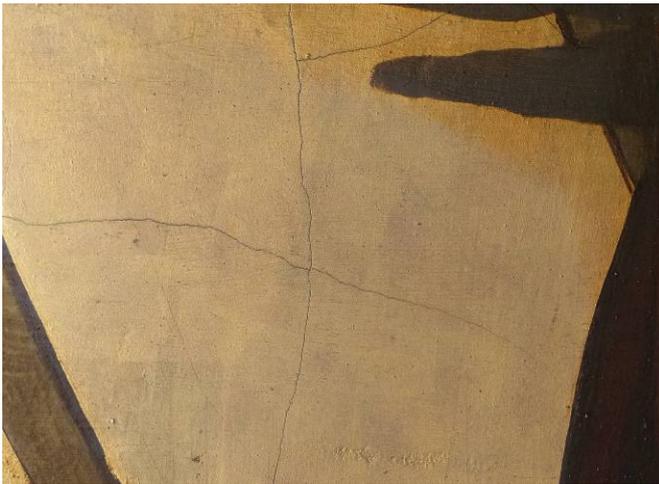
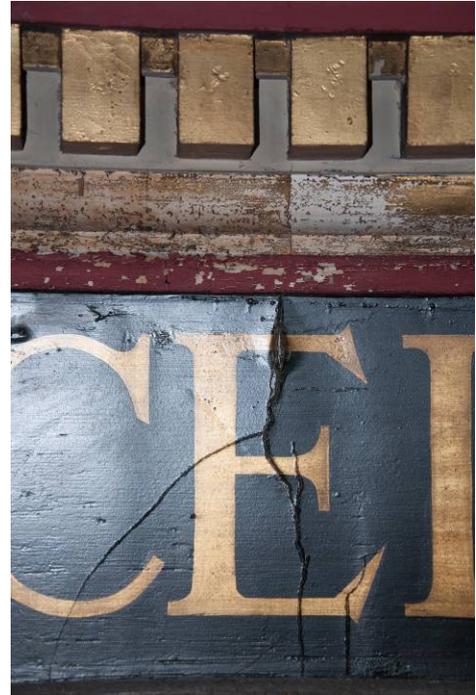
In most areas it was found that the render retained a good level of cohesion and was well bonded to the brick substrate. There were a large number of hairline cracks, but these appeared to be old and dirty and, in most cases, were below the varnish layer. These appeared to have resulted from initial setting cracking and, in some cases, from low-level structural movement. However, none appeared to be recent.

Figures 16 & 17. Historic hairline cracks on the dome and cornice.

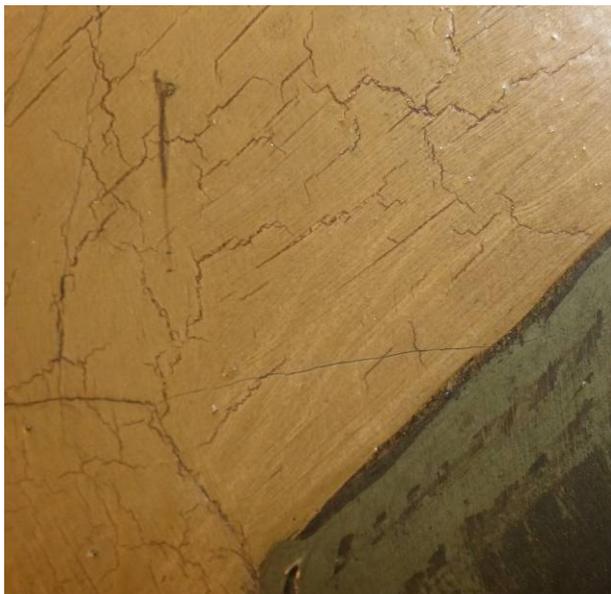
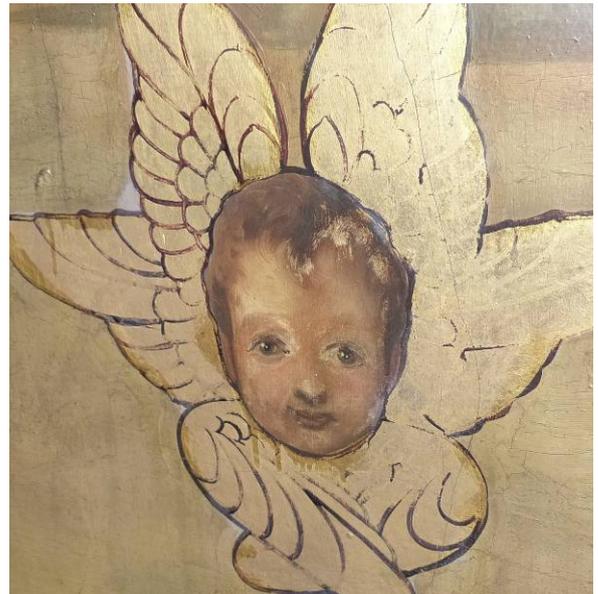
In all areas that were examined, the paint layer retained a good level of cohesion and was well bonded to the plaster substrate. There was a heavy craquelure in most places, but on the ground this was not visible and does not have a significant impact on the appearance of the painting. Some minor discolouration and blanching was also observed on a number of the details, including the faces of the seraphim.

Figures 18 & 19. Detail of the craquelure and of one of the seraphim.

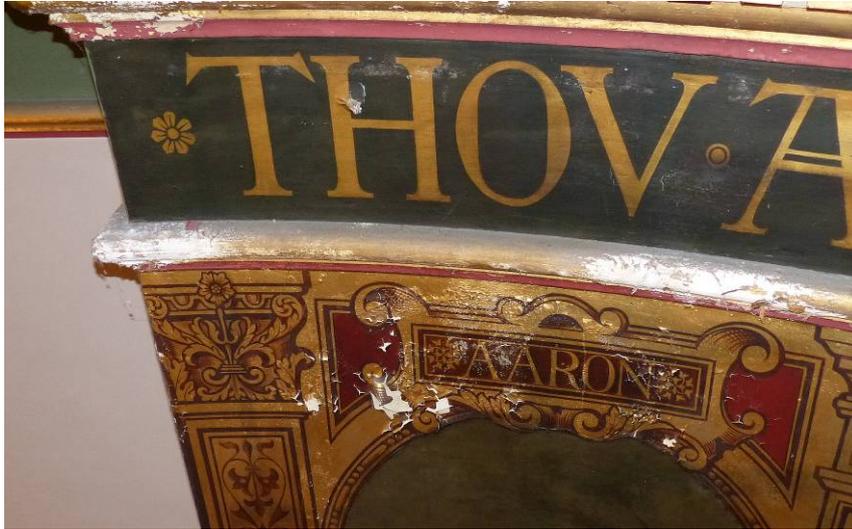
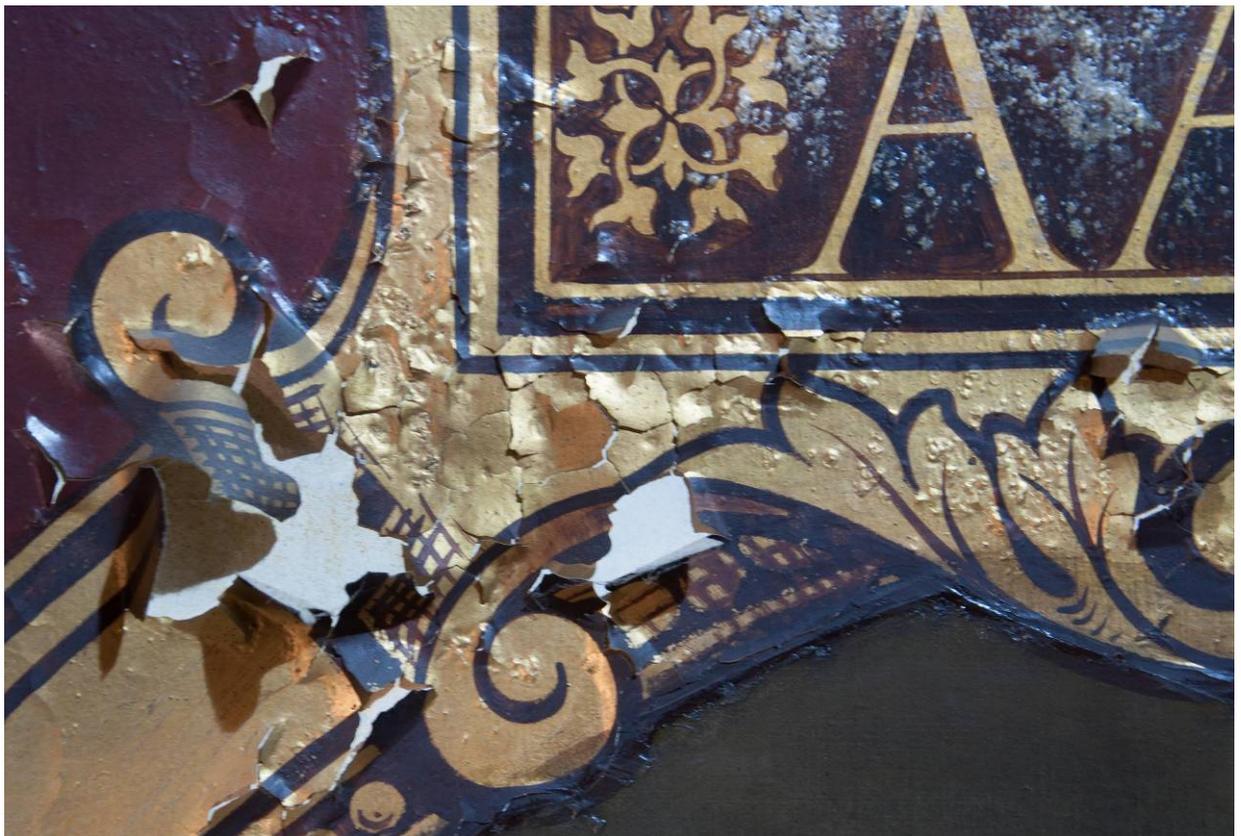
The most serious deterioration had occurred in areas where there had been localised water infiltration at cornice level. The most severe deterioration was on the north side of the apse where, although the plaster retained a good level of cohesion there was extensive delamination of the paint layer at the interface between ground and substrate. This had led to macro flaking with large, well cohered flakes of paint peeling away, as well as micro flaking with very small flakes and a partial loss of cohesion.

Figures 20 & 21. General view of the damage on the north side of the apse and detail of the delamination and flaking of the paint layer.

- *Readhesion of the paint layer:* Readhesion of flaking paint layers was undertaken using a weak solution of the acrylic dispersion Plextol B500.⁶ In areas where the flakes were thick and flexible, the surface was relayed using heated spatulas.

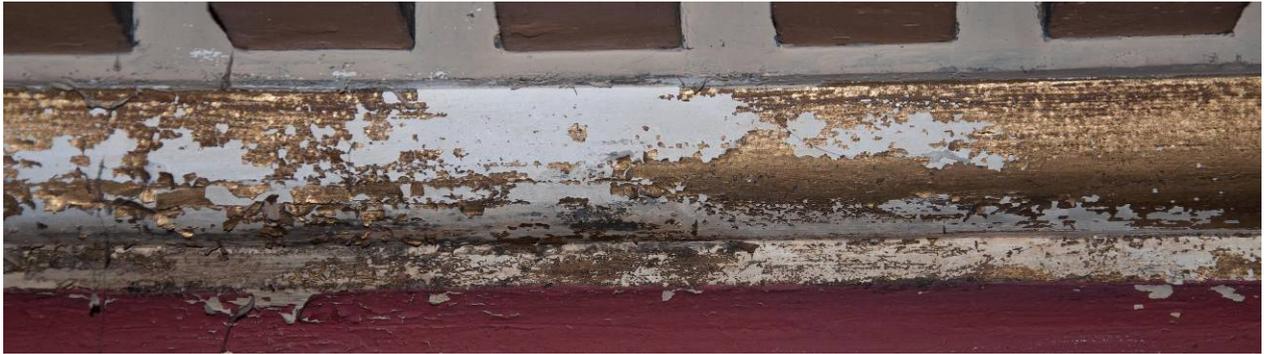
The damage had affected both the paint layer and also the gilding on the moulding which, due to its generally thinner nature and the more aggressive salt activity, had suffered loss of cohesion and widespread loss.

Figure 22. Eastern section of the lower molding on the cornice showing the delamination of the gilding.

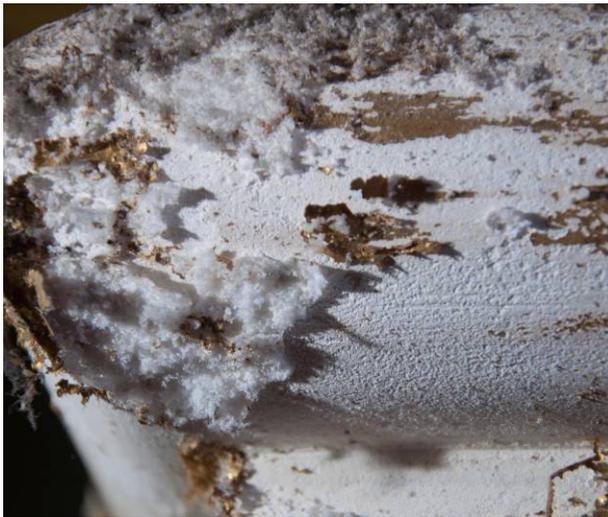
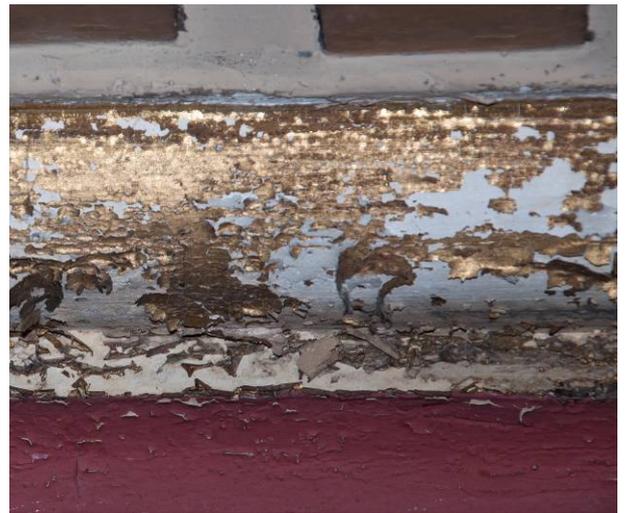
Figures 23 & 24. Raking light details of the salt activity and the micro flaking of the paint layer.

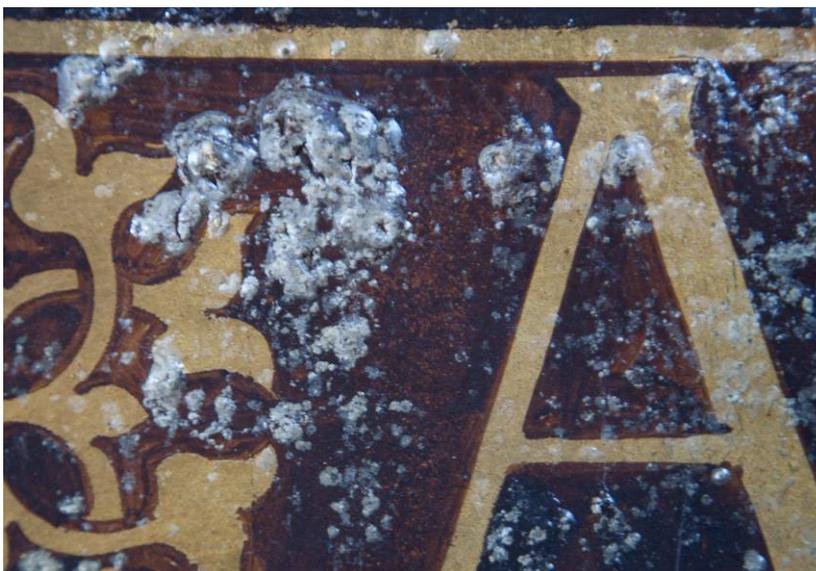
Adjacent to the areas where the paint layer has been lost, there were small sections where there had been delamination between the varnish and paint layer, with salt activity at the interface, resulting in severe blanching.

Figure 25. Delamination and blanching of the varnish.
