HOLY TRINITY CHURCH, GUILDFORD
REMEDIAL CONSERVATION TREATMENT OF THE APSE DOME PAINTINGS
MAY 2016

Report No: GDHT01.2 **Date:** 13th May 2016

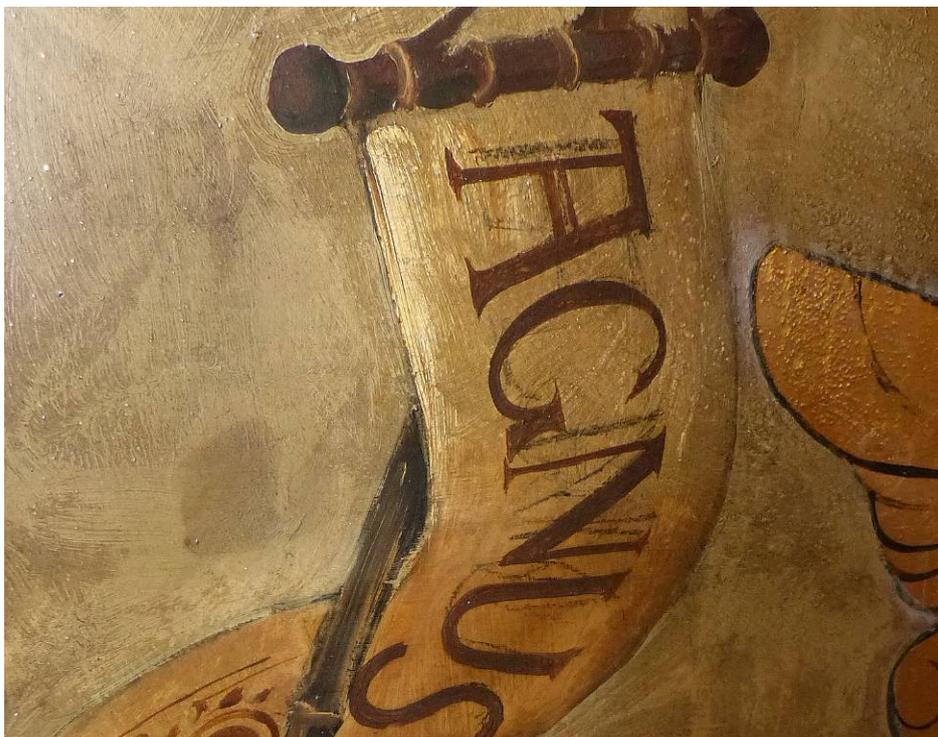
The painting is executed in thick brushstrokes and appears to be oil based. There appears to be a single grey green ground over the whole of the dome onto which the figures are applied. Only limited laying out was observed with coarse underdrawings on the text scrolls

Figure 6. Coarse underdrawing below the text scroll.

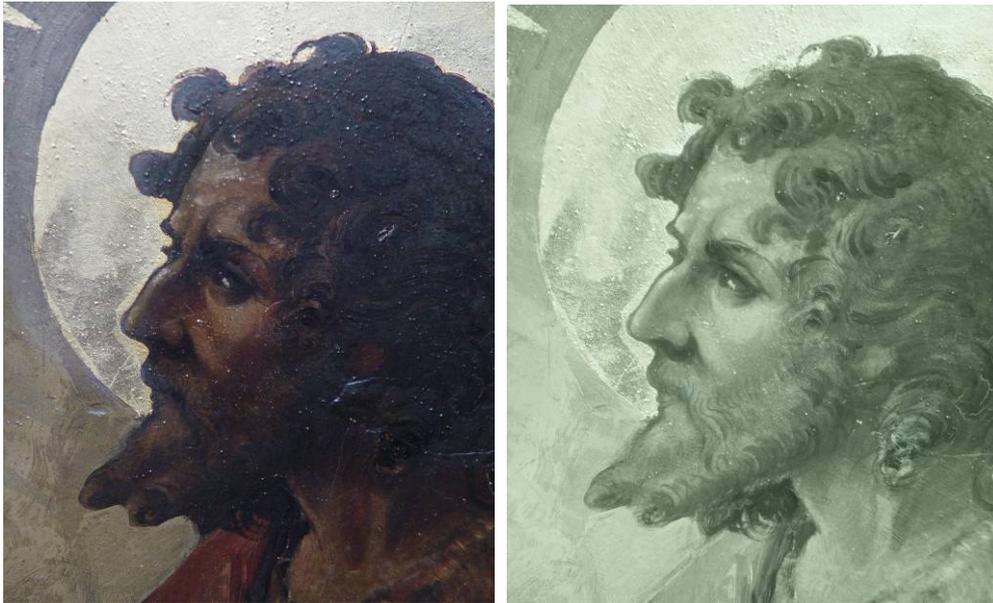
IR imaging showed no obvious underdrawing indicating that the final paint layer is comparatively thick with a high level of coverage.

Figures 7 & 8. Visible and IR image of the face of St John the Baptist shows no obvious underdrawings. (Image: Claudia Fiochetti)
